EVALUATION OF A CABLE-NET ROOF MODEL FOR  
HASTY FUEL STORAGE RESERVOIRS

Report 2041

3. REPORT TITLE		
EVALUATION OF A CABLE-NET ROOF MODEL FOR HASTY FUEL STORAGE RESERVOIRS		
4. DESCRIPTIVE NOTES (Type of report and inclusive dates)		
An Interim Report on a Continuing Hasty Fuel Storage Reservoir Problem (Feb - May 1971)

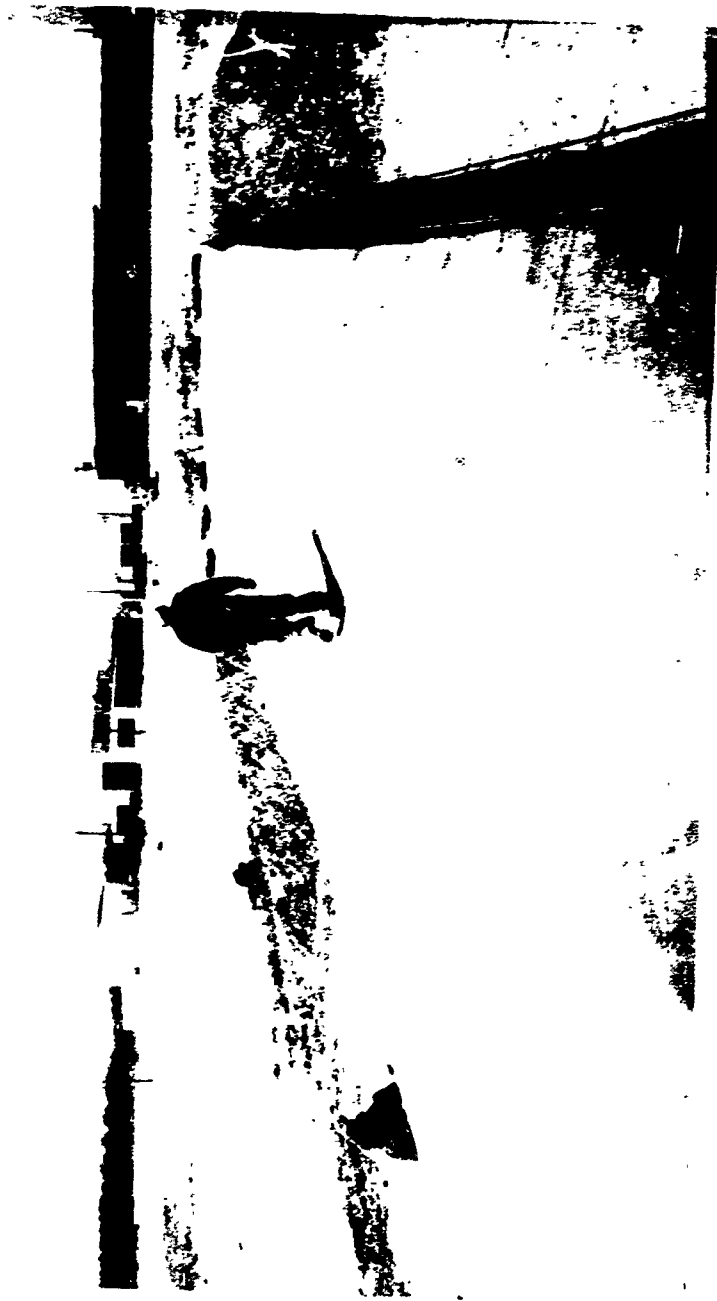
T7064

Fig. 6. Coated fabric covering over cable structure.

After the cables were installed spanning the reservoir between the berms, a section of coated fabric 20 feet long by 110 feet wide was installed over the main cables and anchored down (Fig. 6). Small-diameter cables (1/8 inch in diameter) were then installed at four-foot intervals perpendicular and over the main transverse cables to offer additional support for the coated fabric. In addition, 1/8-inch-diameter cables were installed at 8-foot intervals over the top surface of the coated fabric to prevent an upward lift of the roof from wind forces (Fig. 7).

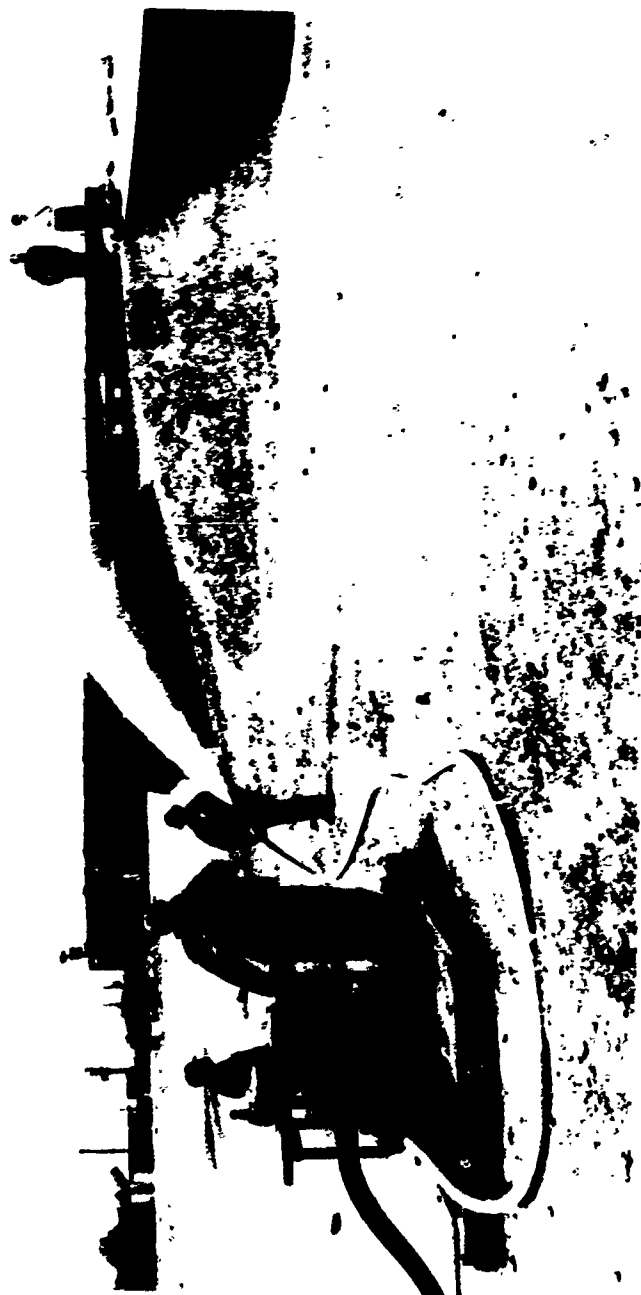
T7132

Fig. 8. Rainfall simulation.

a. **Evaluation of Roof under Simulated Rainfall Conditions.** Rainfall was simulated by spraying water over the entire surface of the roof section using a 2-inch firefighting nozzle and hose attached to a pump and a tank trailer (Fig. 8). The rainfall simulated was a rate of approximately 2 inches per hour for a period of 30 minutes.
